City of Saco

Subject: RFP# 201601017
2016 Grants for Stream Crossing Public Infrastructure Improvements

The City is proposing to replace the existing Industrial Park Road culvert at the Goosefare Brook crossing. The existing culvert crossing has been selected for your consideration through the Grant Process due to the following reasons:

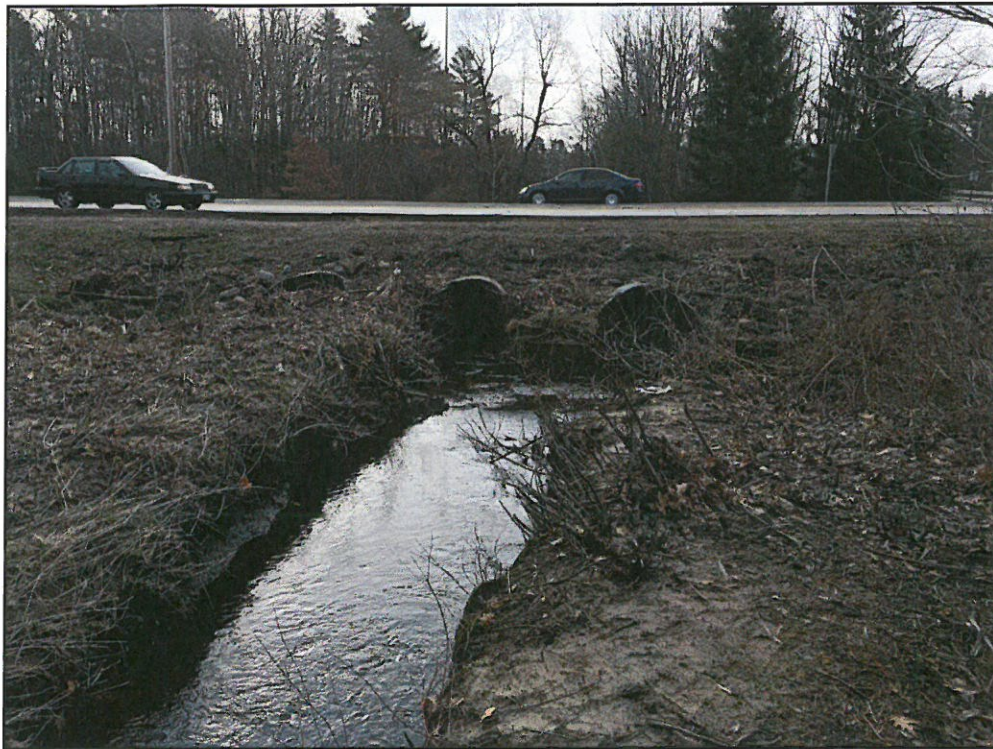
- **Flooding and Debris Management** – During significant rainfall events, high water occurs on the inlet side of the culvert due to debris accumulation. This is largely due to the multiple barrel configuration of the culvert installation.

Industrial Park Road has overtopped slightly during two previous major storm events over the past 20 years. The cause for the overtopping was due to debris blockage on the inlet end of the culvert. No significant damage was caused during these events and road remained passable at all times.

Photo Description: View of existing conditions at culvert inlet.

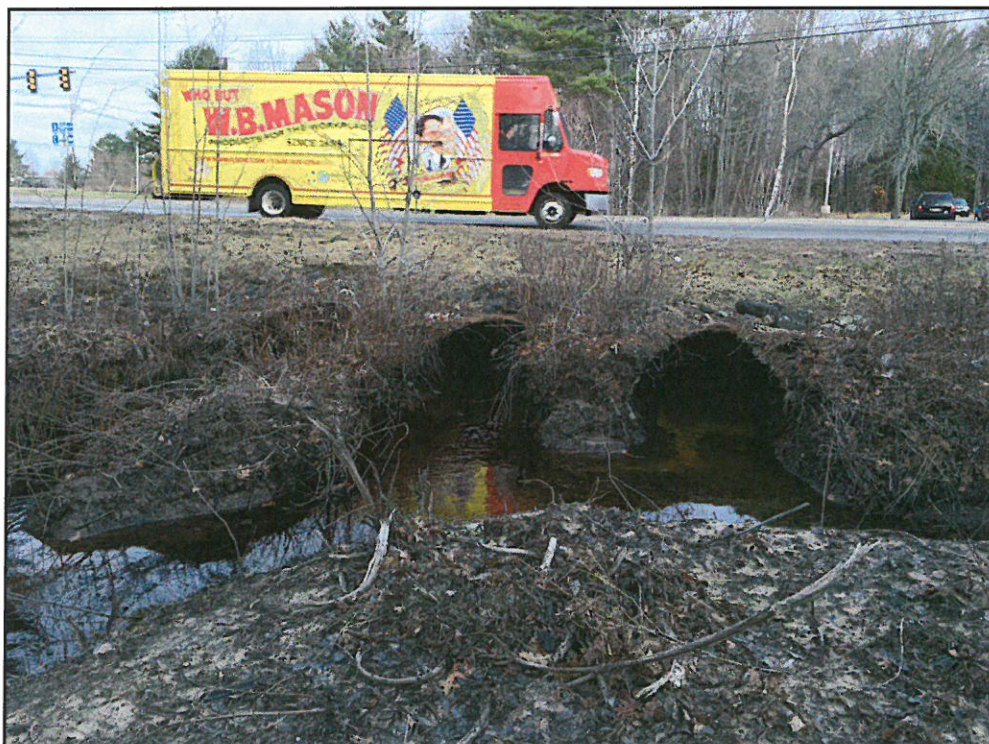
Photo Description: View of existing conditions at culvert outlet.

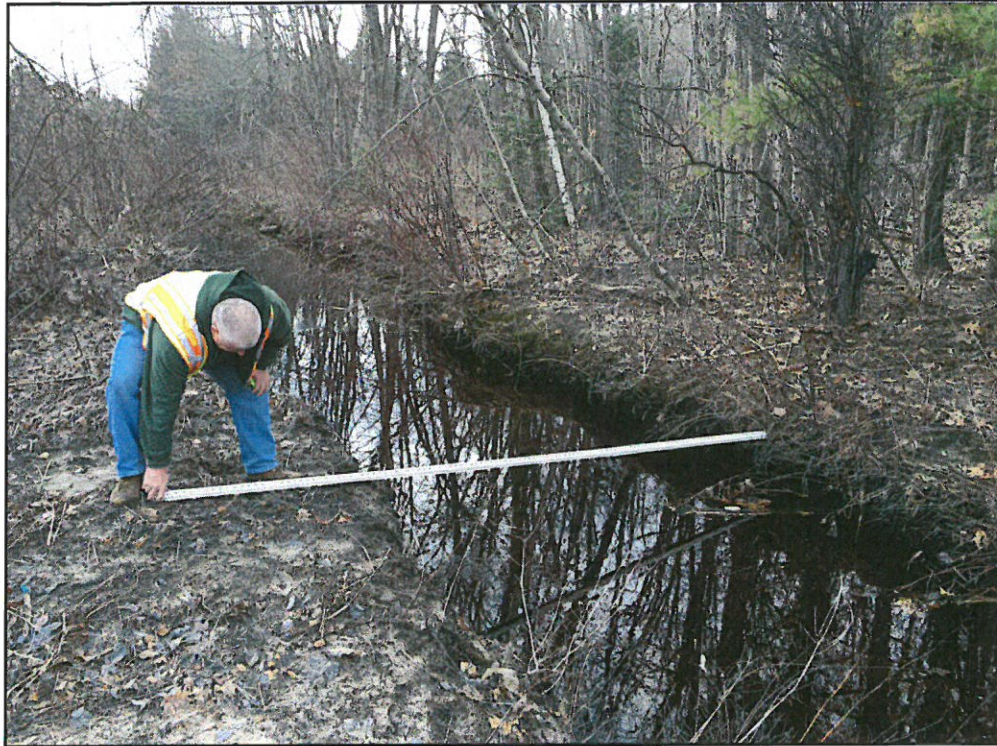
Width of natural stream (not pool at culvert):
8' to 9'

Photo Description: View of field measurement of stream full bank width.

Yes. Replacement culvert will have a clear opening width of 16', which exceeds the 1.2 times bank

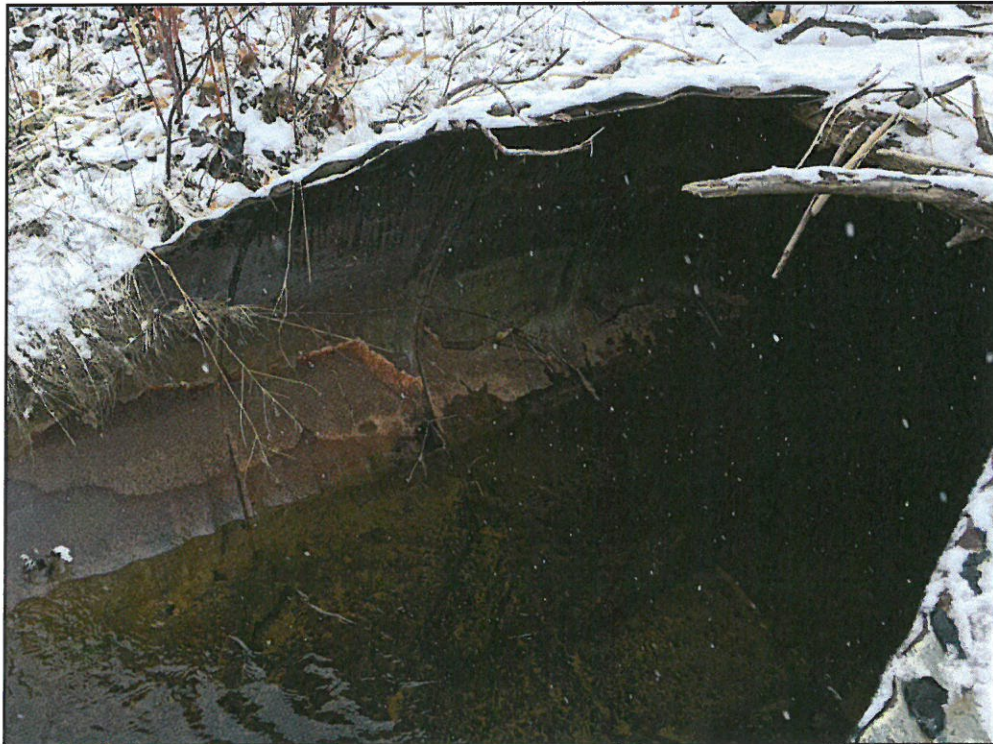
- **Condition** – The existing triple barrel (71" x 47") corrugated metal arch pipe crossing was installed in the early 1980's. The protective coating system for the culverts has failed and deterioration of the culvert pipe material has accelerated. It is estimated that the existing culvert will need to be replaced within the next 5 to 10 year time period.

Existing culvert crossing consists of triple barrel, corrugated metal arch culverts (71" by 47" size each) that were installed in the early 1980's. The culverts are in fair condition. Much of the factory applied protective coatings are gone and the culvert material is deteriorating. Several joints are known to be open resulting minor sink holes in the roadway and embankment.

Photo Description: View of existing conditions at culvert pipe (Note poor condition of pipe and protective coating).

Proposed culvert/crossing material: Circle One (Plastic pipe, concrete pipe, corrugated metal pipe, concrete box culvert, stone/granite culvert, pipe arch, bridge, or Other type (describe): **Three sided concrete bridge**
